Manhole Inspection Summary

Manhole # S45C__039MH

Insp Date: **8/19/08 8:54 AM**

Location Address: **WASHINGTON**

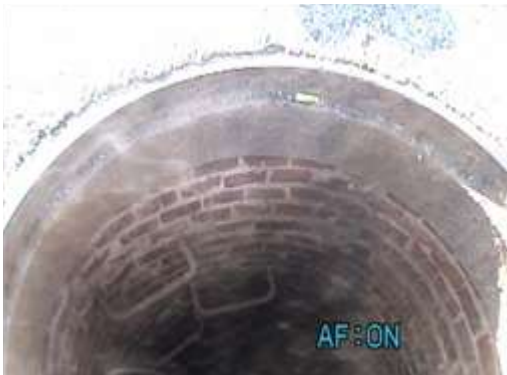
Defect 2

Frame Offset: **1** (in.) Condition: ☐ Sound ☐ Cracked ☒ **Leaks**

Frame leaks

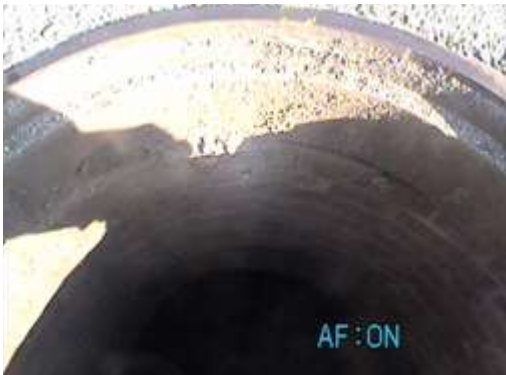
Defect 1

Infiltration: ☐ None ☐ Joint ☐ Cracks ☒ **Mortar** ☐ Roots ☐ Wall

Infiltration

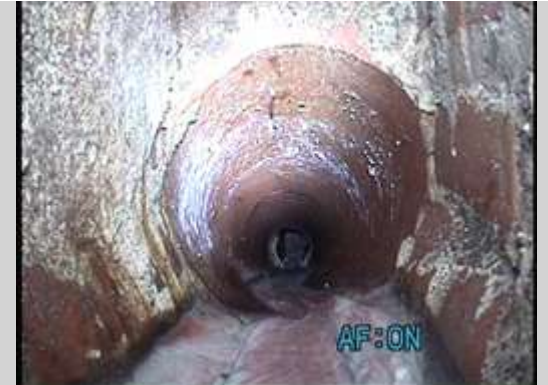
12 O'Clock Outflow

8 in. Circular Gravity Sewer
Pipe Out @ 12 O'Clock

Pipe Height: **8.4** (in.) Rod and Bar (Angled)
Pipe Material: **Clay** ☐ Pipe Lined
Invert Depth: **10.35** (ft.) Flow Characteristics: **Fast**
Deposits: ☒ None ☐ Mud ☐ Sludge ☐ Debris ☐ Grease
Silt Depth: (in.) Deposits Extent:
Infiltration: **None** Pipe Seal Cond: **Sound**

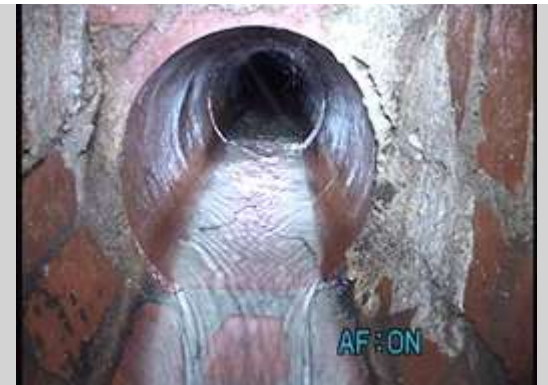
2 O'Clock Inflow

8 in. Circular Gravity Sewer
Pipe In @ 2 O'Clock

Pipe Height: **8.4** (in.) Rod and Bar (Angled)
Pipe Material: **Clay** ☐ Pipe Lined
Invert Depth: **9.75** (ft.) Flow Characteristics: **Fast**
Deposits: ☒ None ☐ Mud ☐ Sludge ☐ Debris ☐ Grease
Silt Depth: (in.) Deposits Extent:
Infiltration: **None** Pipe Seal Cond: **Sound**
